**State of Louisiana  
Department of Natural Resources  
Coastal Engineering Division**

**2005/2006 Annual Inspection  
Report**

**LAKE CHAPEAU HYDROLOGIC  
RESTORATION**

State Project Number TE-26  
Priority Project List 2

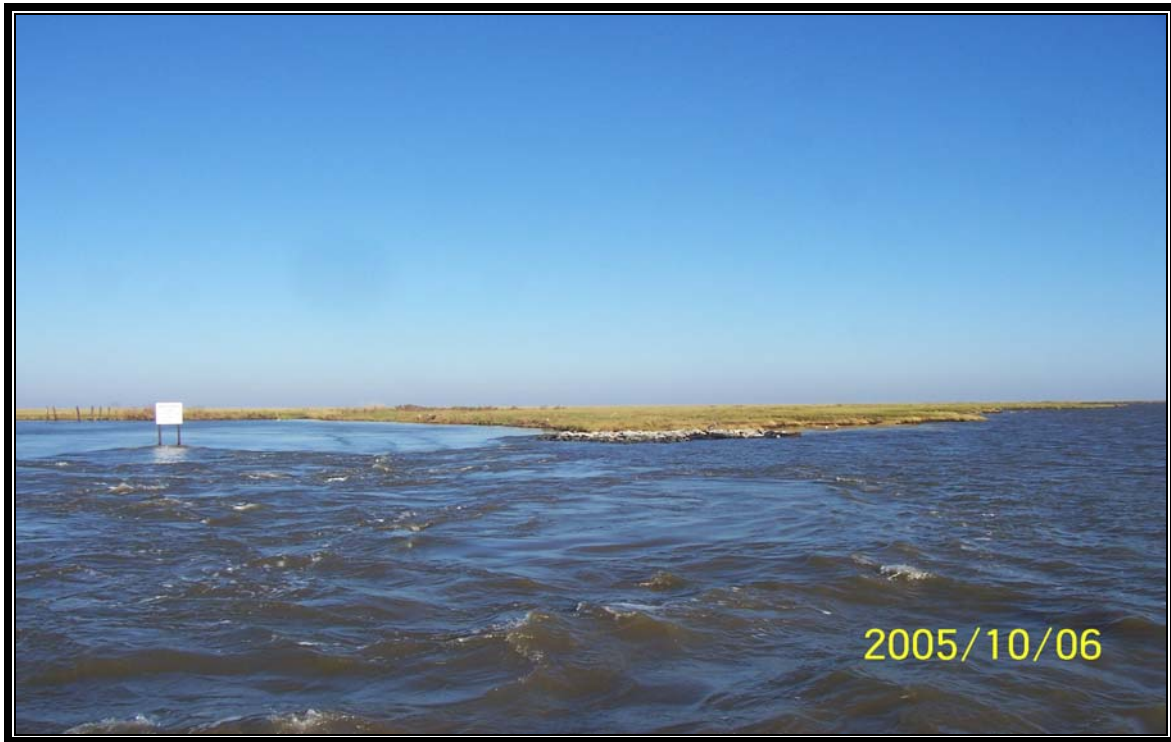
*TE-26 – Structure No.3 – photo showing erosion along the shoreline north of rock rip rap weir looking west.*

From visual observation of the existing project features, we found significant erosion along the shoreline on the north side of structure no.3. Although erosion in this area was evident, the structure has not breached and no negative impacts are expected in the immediate future. As the bank line erodes in this area, the rock weir connection to the marsh will become breached and repairs will be required. At this time, we do not recommend any corrective actions. No FEMA claims are warranted.

Repair breach along existing marsh adjacent to Structure No.3. Estimated quantity of rock for maintenance repairs is 1,370 tons.

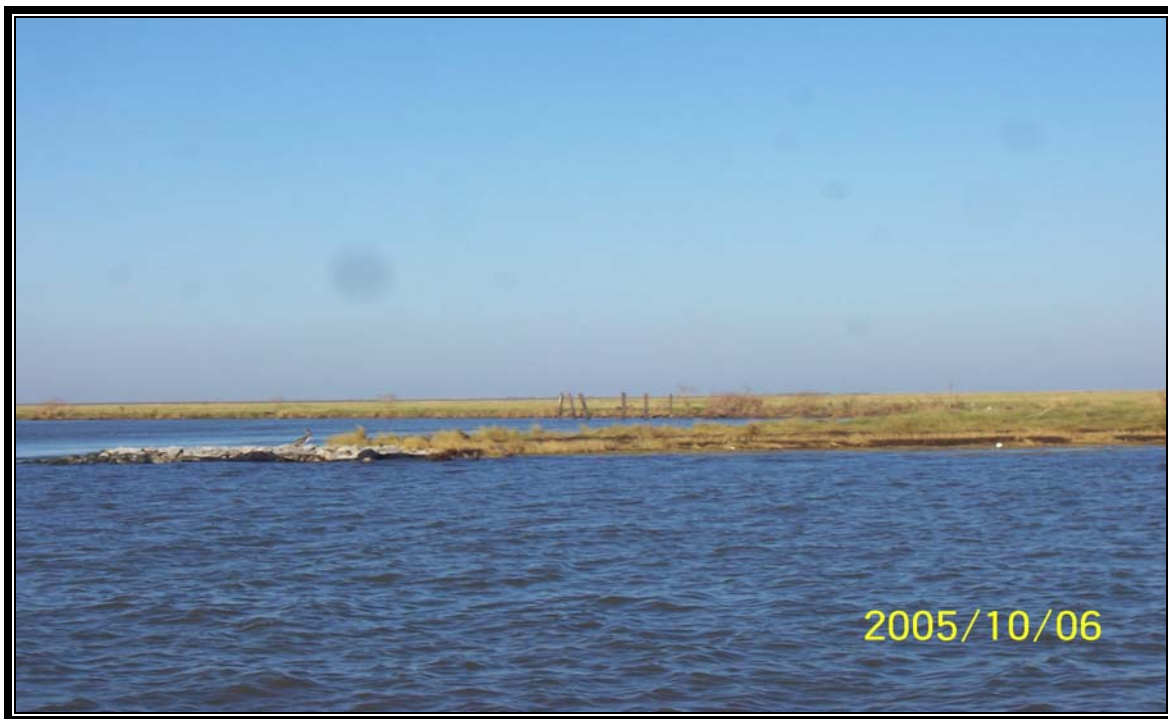
*TE-26 – Structure No.3 – photo showing erosion along the shoreline on the north side of structure looking southwest.*

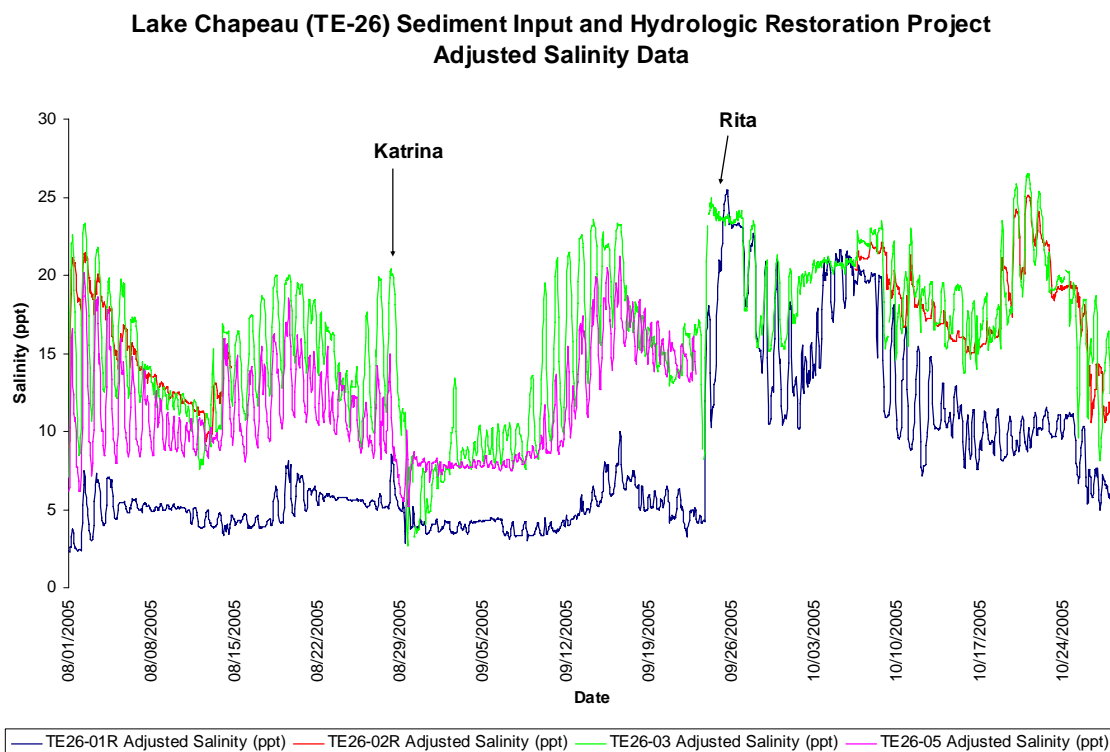
During Hurricanes Katrina and Rita, four continuous recorders remained in place and captured the effects of the hurricanes with respect to the salinity and water levels. Figure 1 illustrates the location of the four continuous recorders. Figures 2 and 3 illustrate the salinity and water level response as a result of the passing of the hurricanes.

**Figure 2: Salinity comparison of the four continuous recorders associated with the project.**

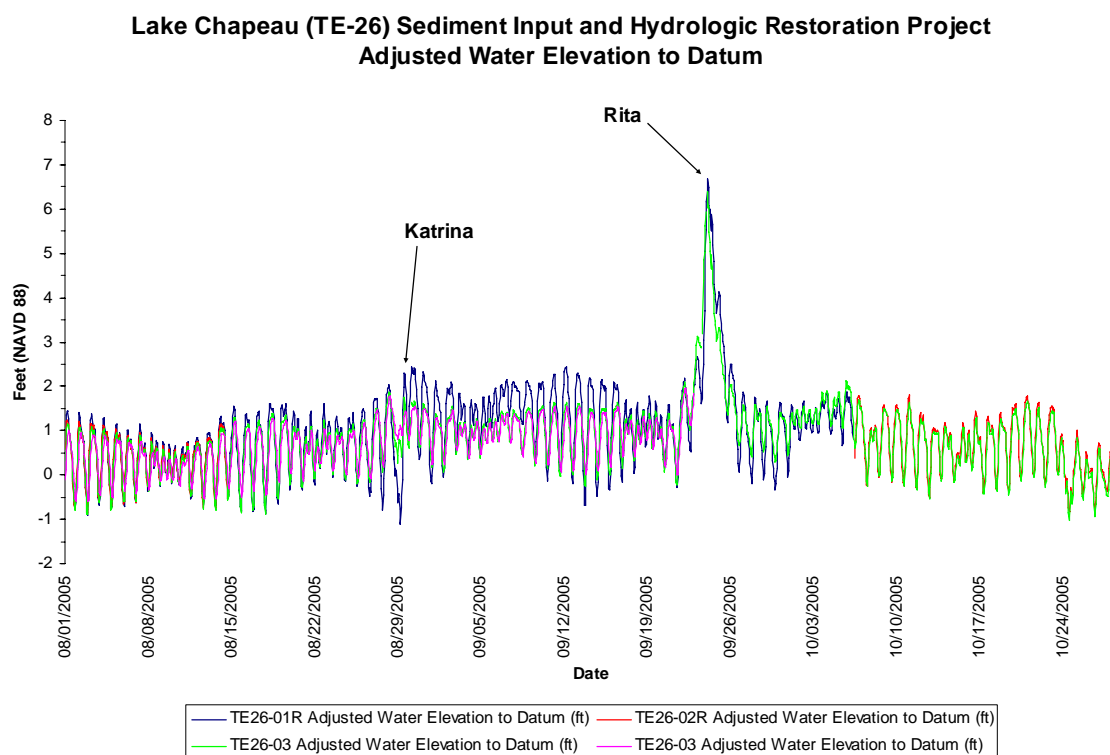
**Figure 3: Water level comparison of the four continuous recorders associated with the project.**
